Waterfront Facilities Inspection

Naval Training Center
Great Lakes, Illinois

RE: Contract N-62472-87-C-7706 - WATERFRONT FACILITIES INSPECTION

WATERFRONT FACILITIES INSPECTION
FOR THE
NAVAL TRAINING CENTER
GREAT LAKES, ILLINOIS

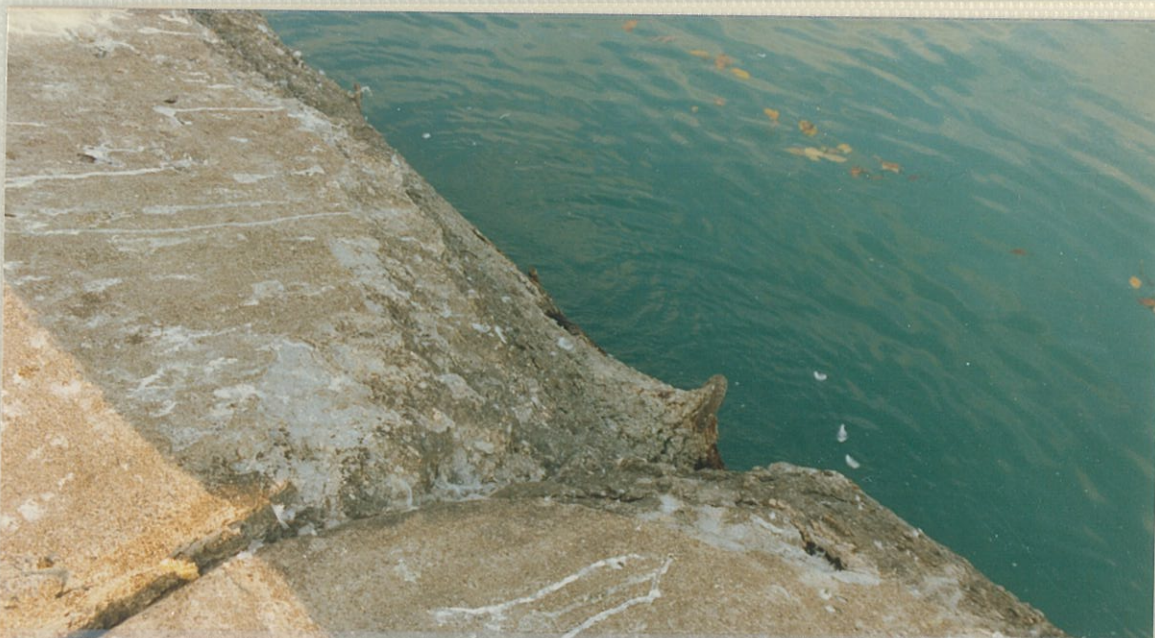
Photo 5.07 - Exposed reinforcing steel on east side of North Breakwater caisson.

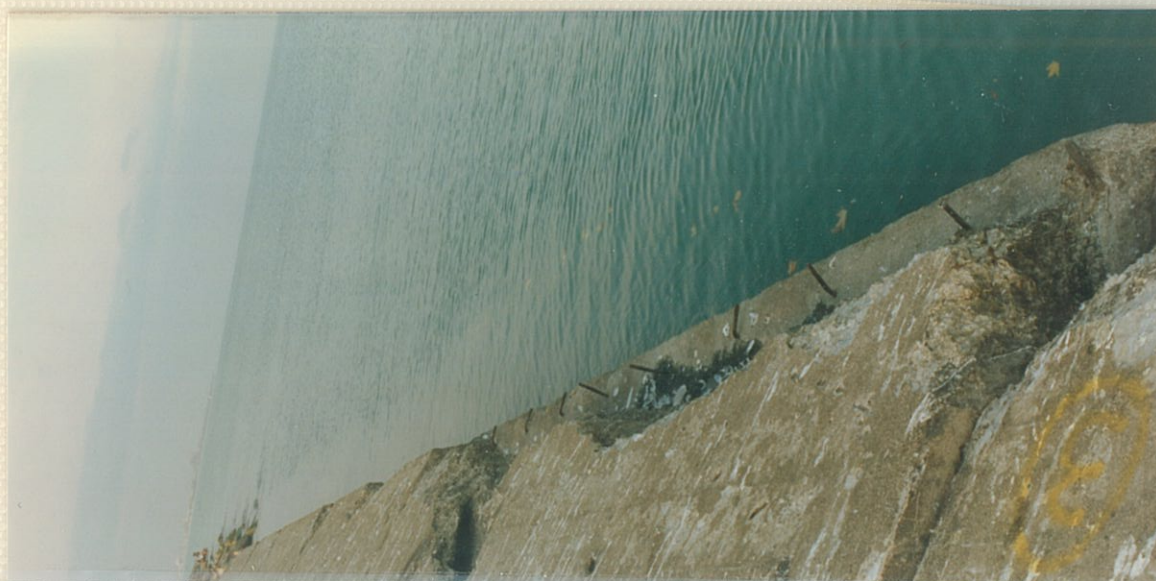
Photo 5.18 - Top of North Breakwater caisson exposed due to spalling of concrete cap.

- a) Concrete Caisson - The portion of the north breakwater consisting of concrete caisson is in fair condition considering its age. The spalling of the concrete continues unchecked and is slightly worse than that which was reported in the 1980 inspection report. The reinforcing in the concrete cap has been exposed and a

a) Concrete Caisson	- Repair deteriorated concrete cap	\$ 11,500	\$ 26,500	\$ 38,000
	- Repair concrete surface deterioration	3,250	15,750	19,000
b) Limestone Rubble Mound	- Monitor stability			----

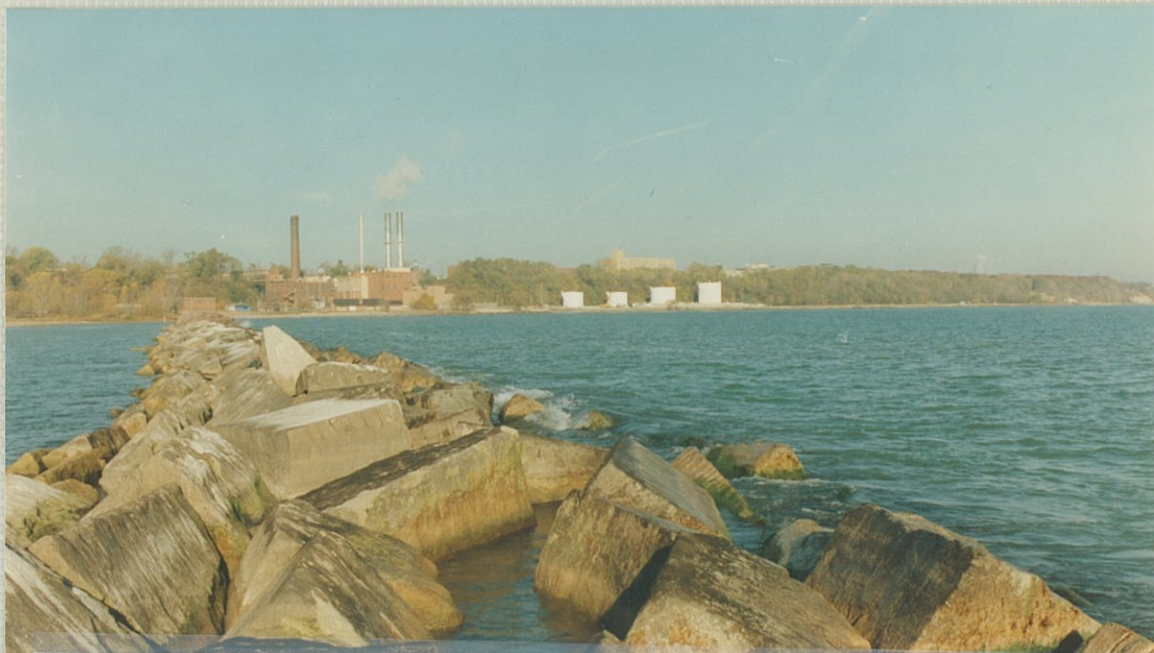
Photo 2.24 - Settlement of limestone section of North Breakwater.

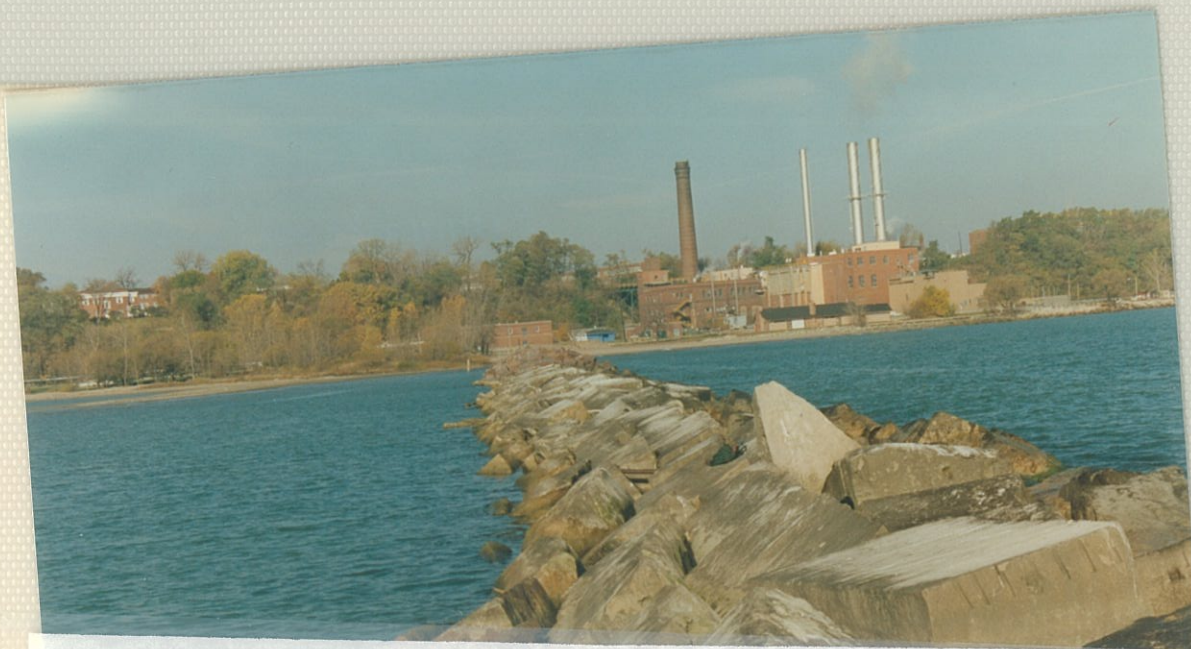
Photo 3.01 - Weathering of North Breakwater limestone has reduced average stone size.

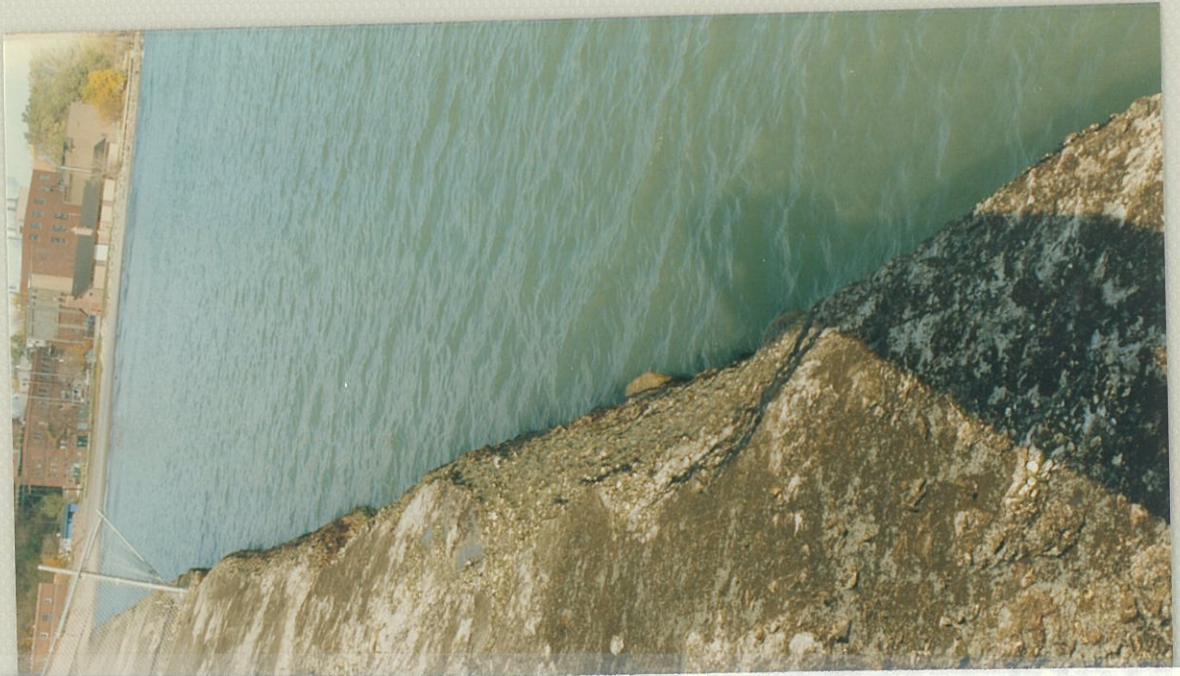
Photo 3.12 - Exposed timber piles on north side of North Breakwater capping section.

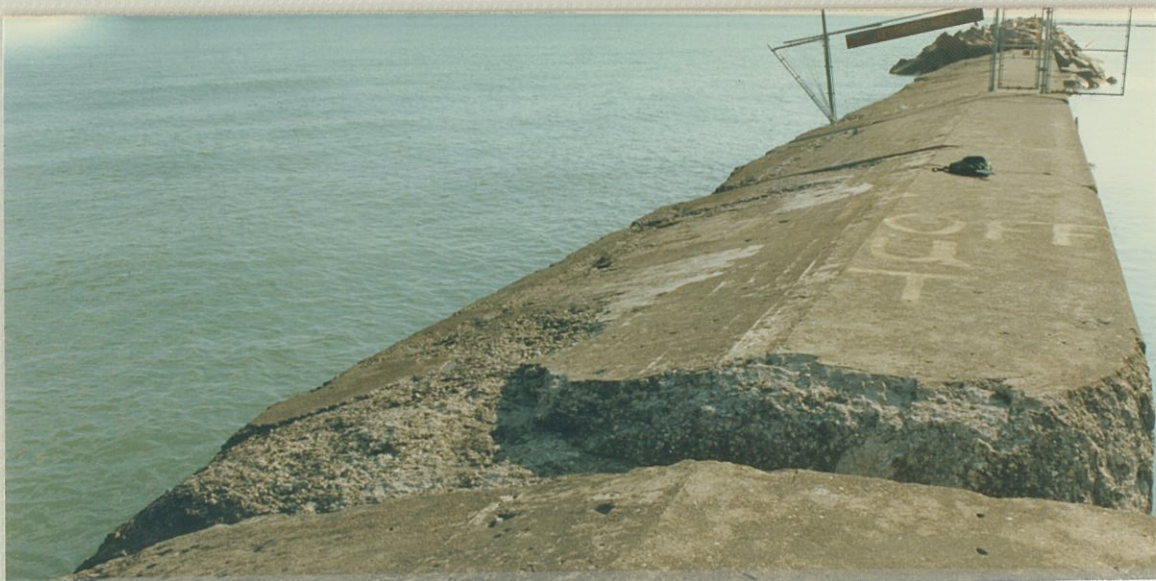
Photo 3.21 - Damaged capping section near North Breakwater station 27+50.

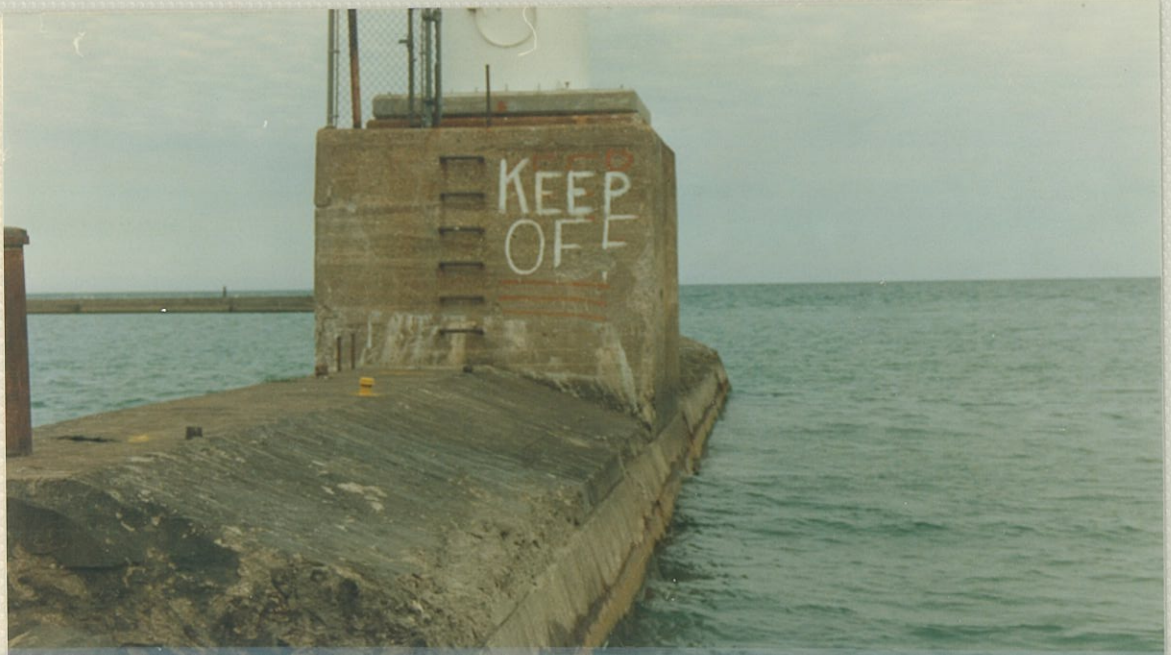
Photo 1.03 - Surface spalling on South Breakwater caisson.

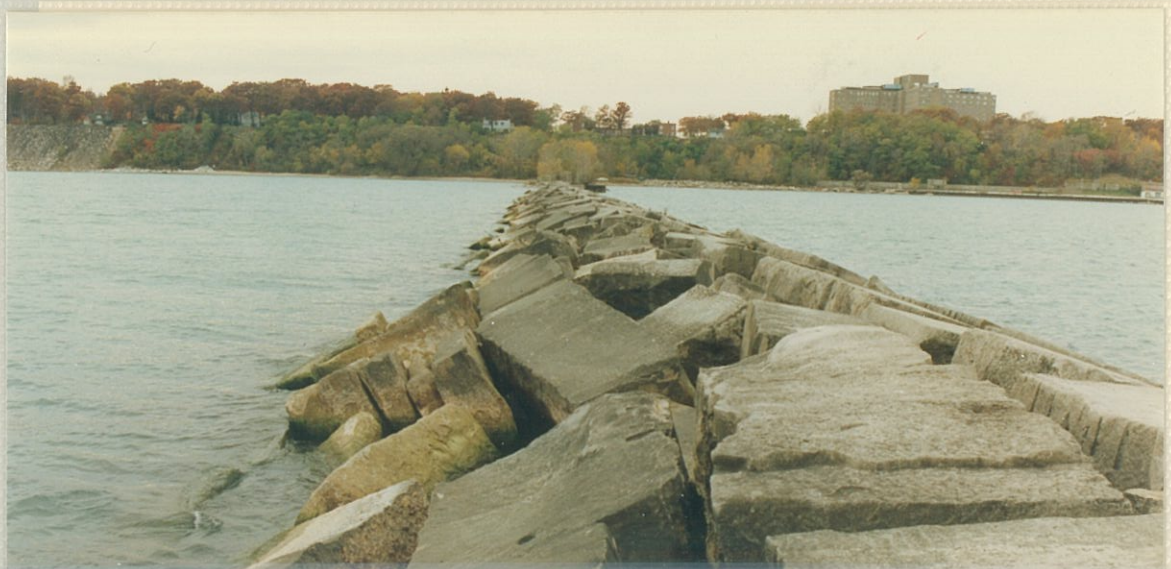
- b) Limestone Rubble Mound - The Bedford Limestone section portion of the north breakwater is in better condition than the north breakwater (Photo 1.17). This is as expected since wave activity from the southeast is not as severe and frequent as that which occurs from the northeast. The stone appears to have settled somewhat; however, the change in cross section is not substantial. Individual stones on this structure are broken, often into thirds. These broken stones often settle out, leaving voids the size of the original stones in the breakwater crest. These voids should be monitored periodically. Water depths adjacent to this structure do not appear to pose a serious problem at this time, but have become more shallow (Photo 1.09).

Photo 1.17 - Bedford limestone section on South Breakwater.

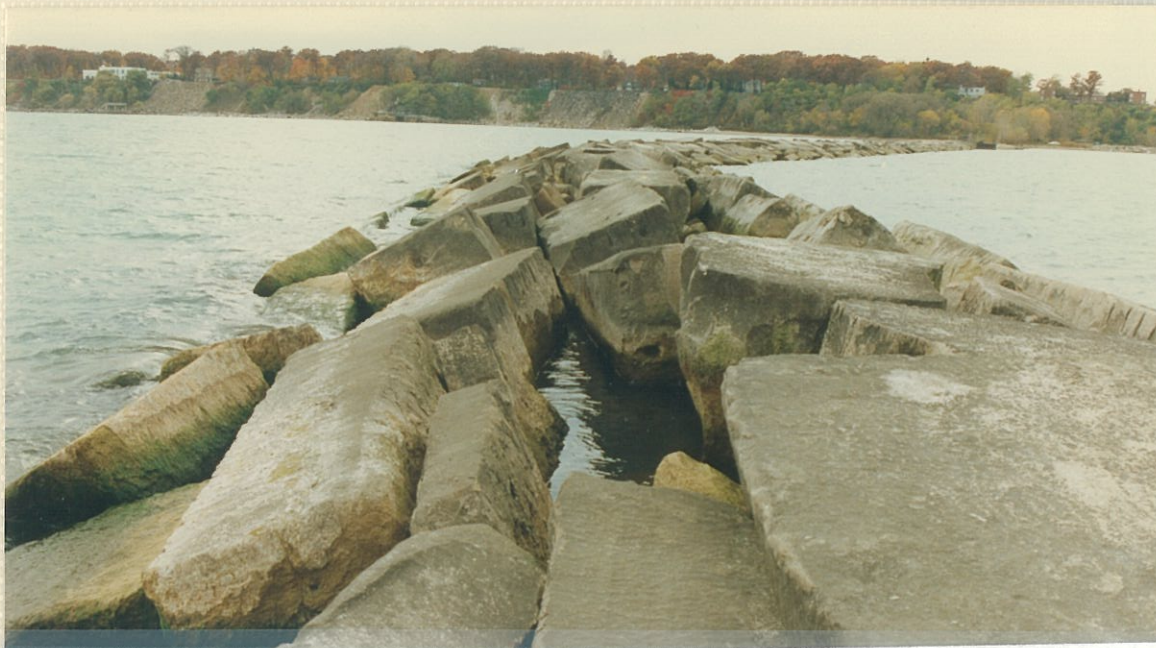
Photo 1.09 - Voids in South Breakwater limestone section due to weathering and settlement of stones.

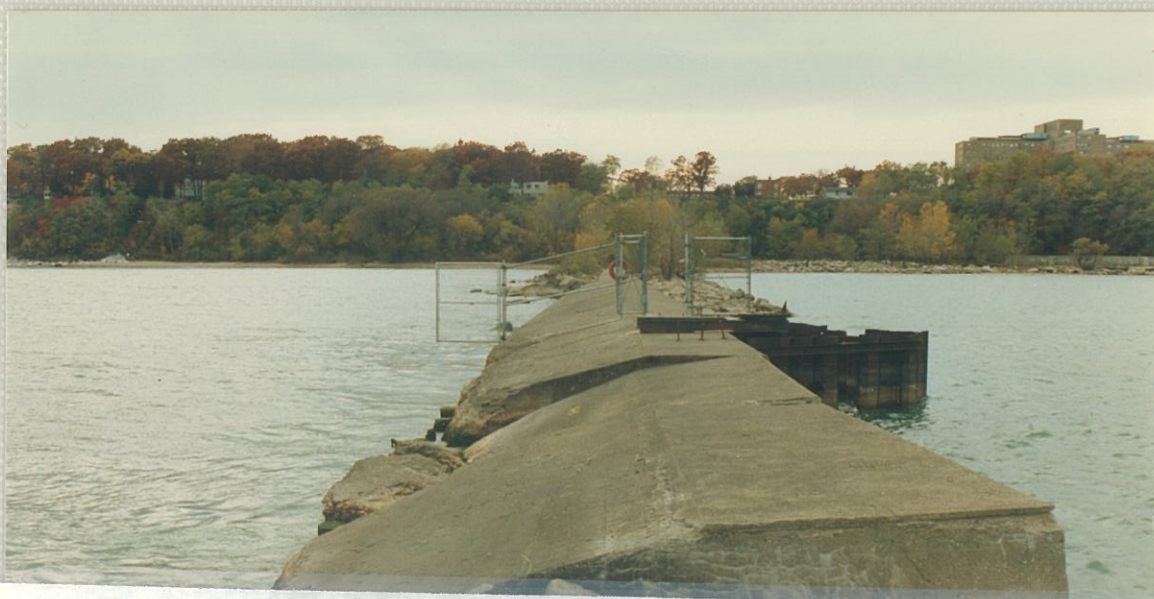
Photo 1.23 - Failure of capping sections on South Breakwater.

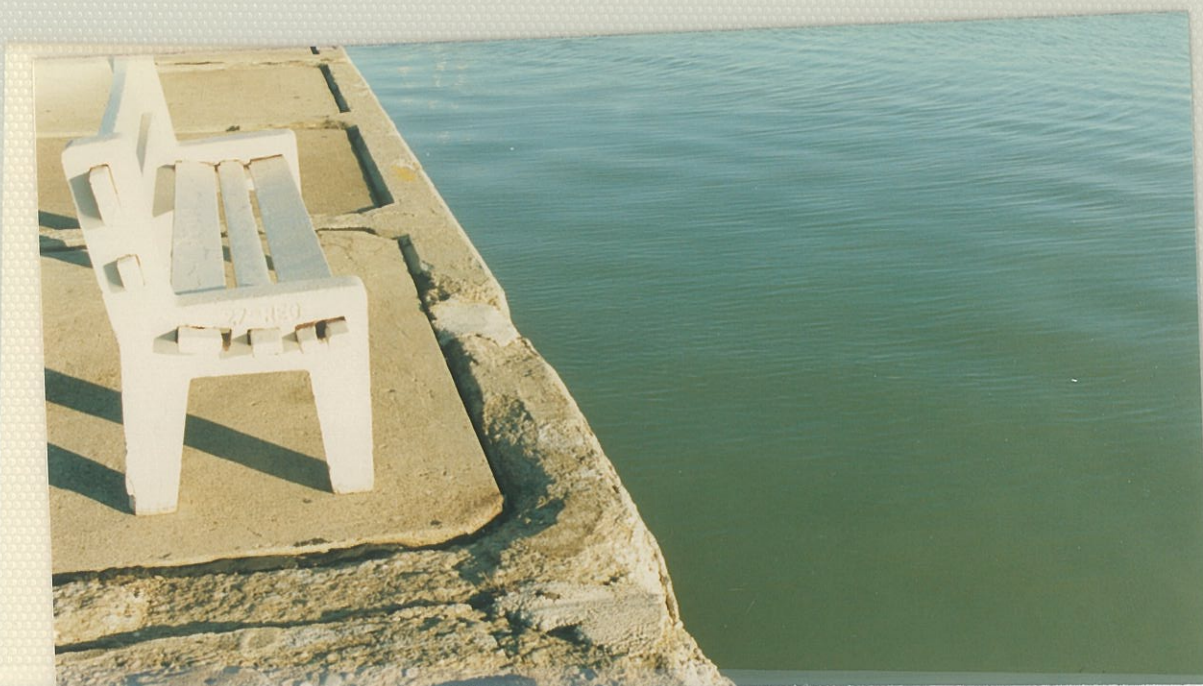
Photo 7.17 - Surface spalling on North Pier.

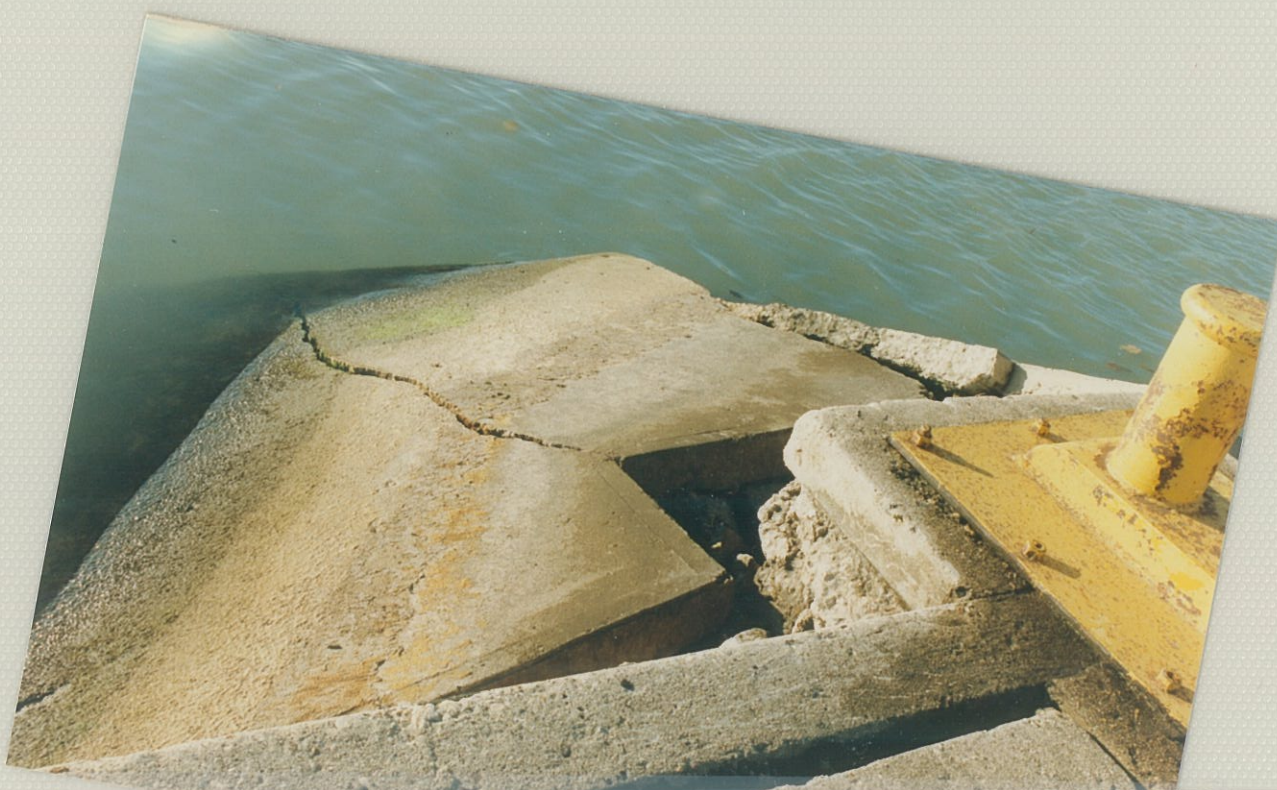
Extensive concrete loss has occurred at construction joints at Stations 3+28, 3+90, and 4+15. At these locations, the entire thickness of the concrete capping wall appears to have been lost. Previous attempts at patching are apparent; however, the attempts focused on the top of the section and holes were left in the vertical face of the pier.

Photo 8.01 - Collapsed section of North Pier.

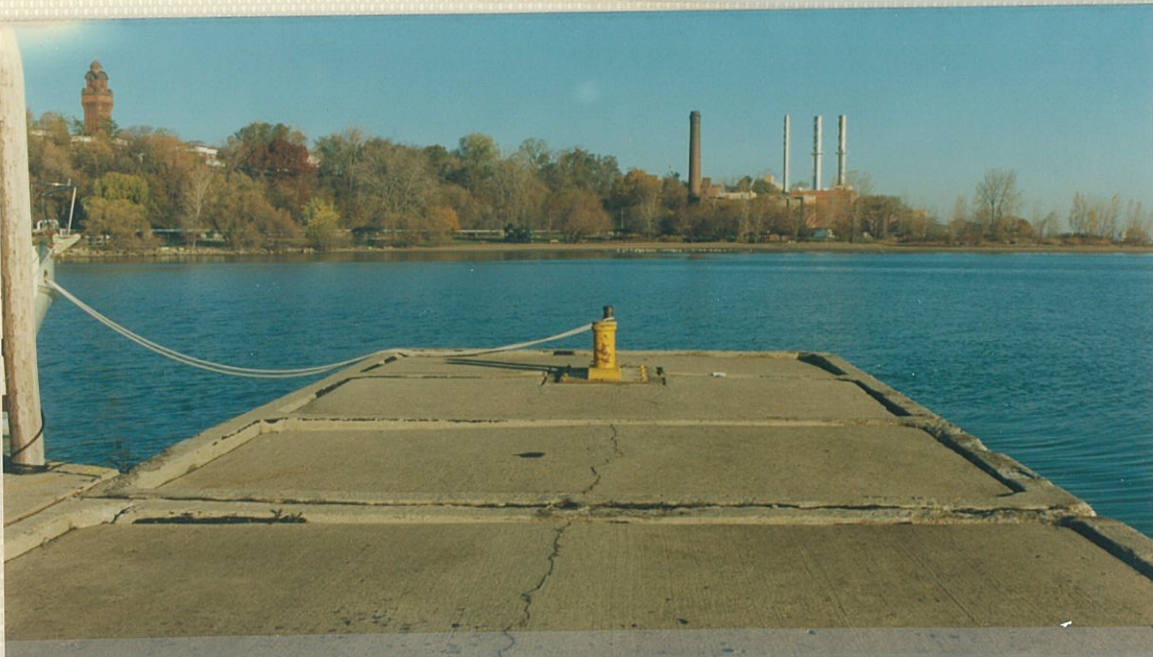
Photo 7.15 - Settlement cracking on North Pier.

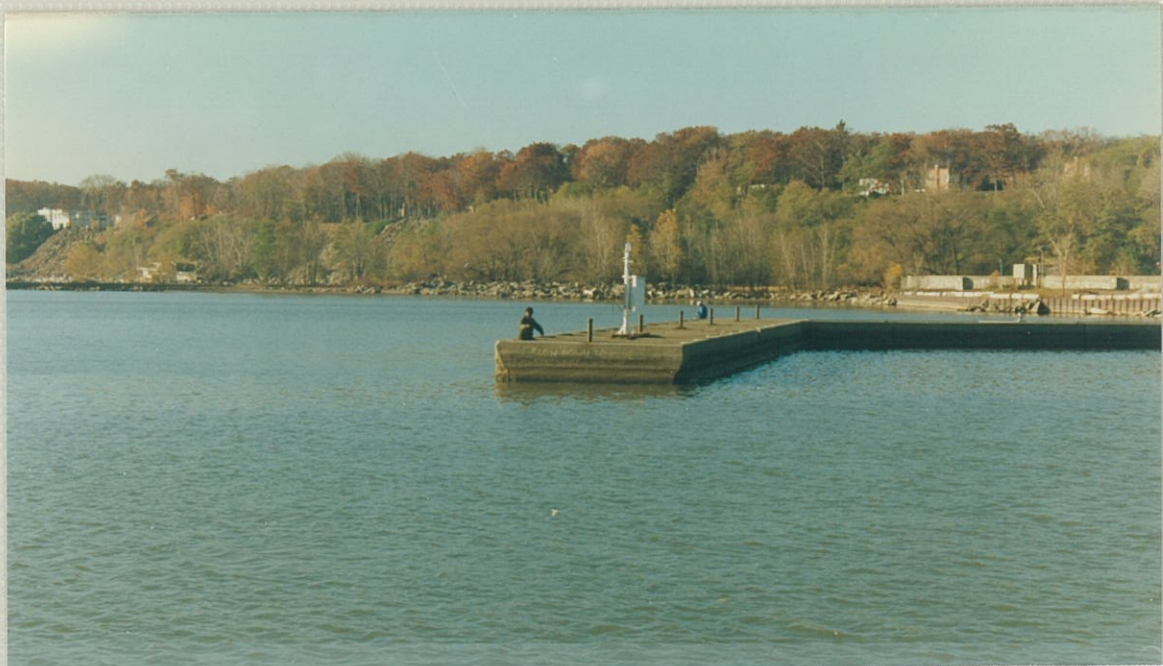
Photo 7.22 - Spalling of outer corners on South Pier.

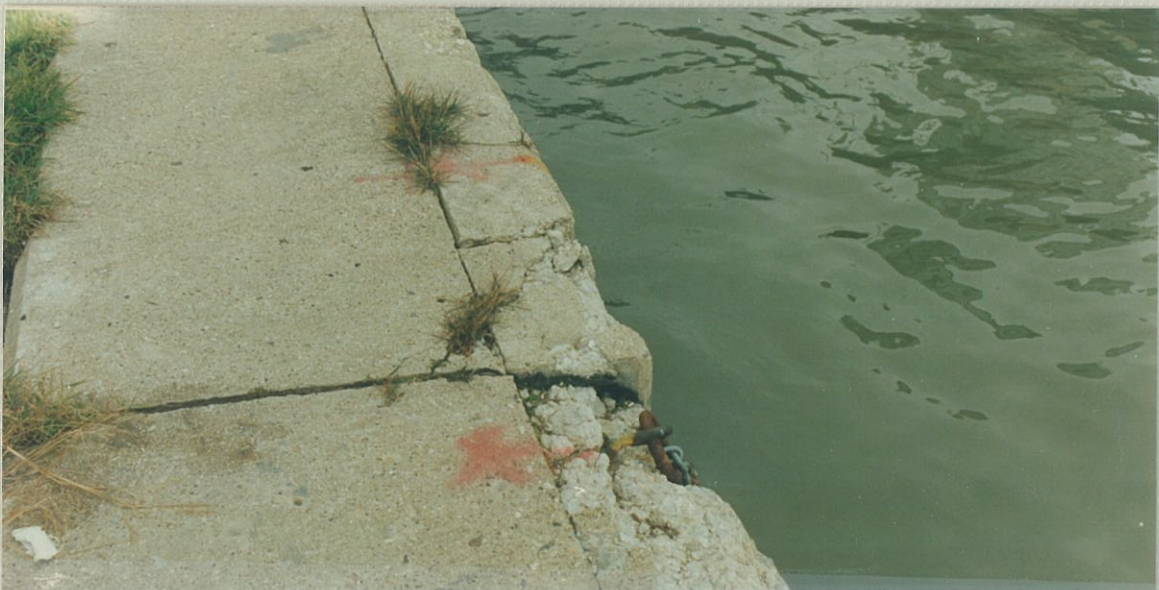
Photo 6.22 - Severe spalling on South Pier.

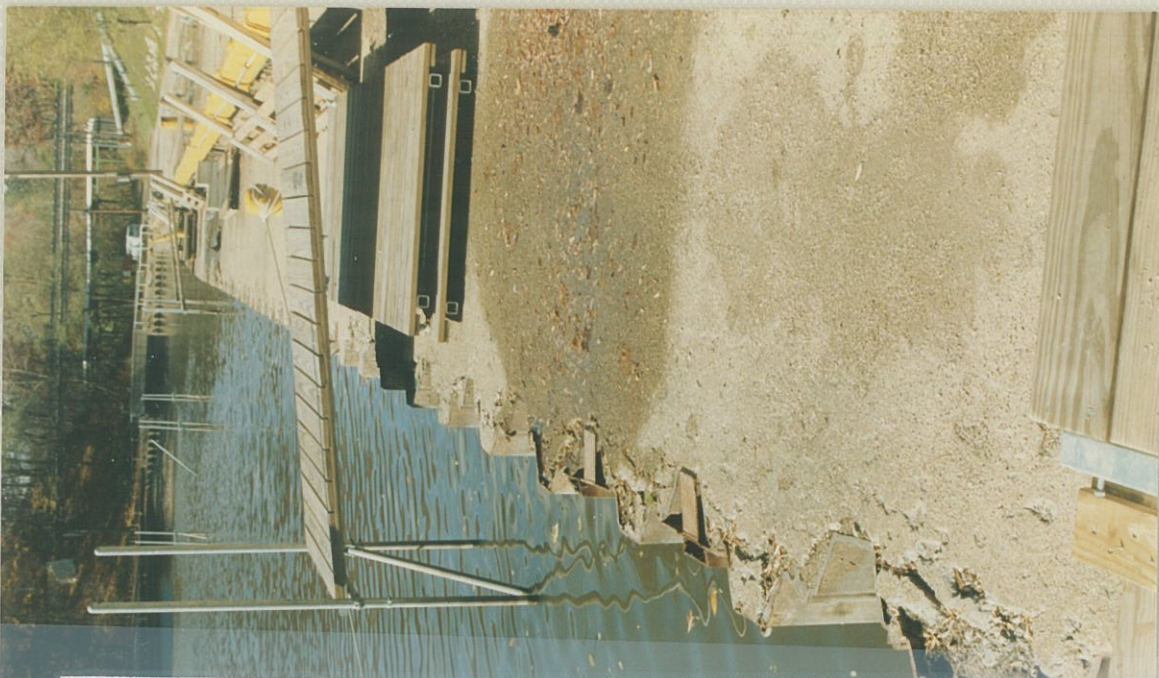
Photo 10.22 - Poor drainage on Boat Basin deck.

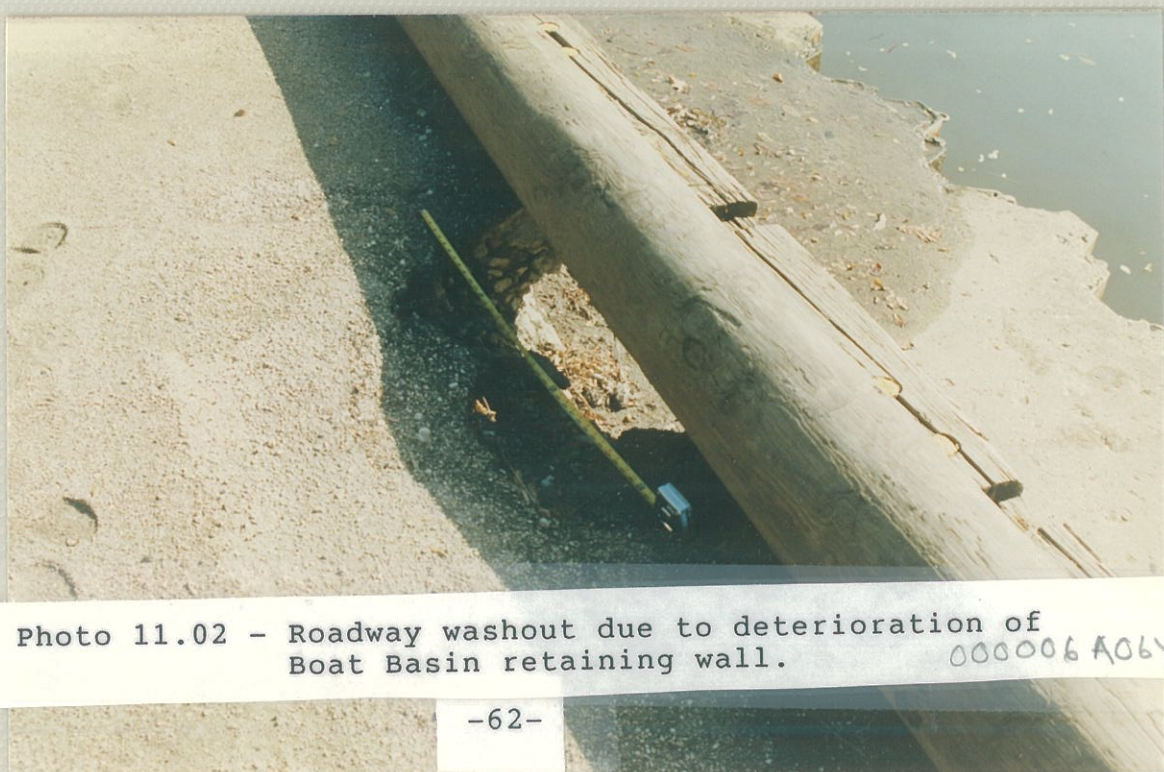
Similar instability was observed behind the north basin wall. On this side of the basin, an asphalt roadway is located immediately adjacent to the original retaining wall. Damage and loss of the original retaining wall has resulted in erosion and failure of the roadway embankment at the following stations 7+52NB, 7+70NB, 7+80NB, 8+50NB, 8+85MB, 9+50NB, 9+75NB, and 10+04NB. This problem may be exacerbated by stormwater runoff at the edge of the roadway (Photo 11.02).

Photo 11.02 - Roadway washout due to deterioration of Boat Basin retaining wall.

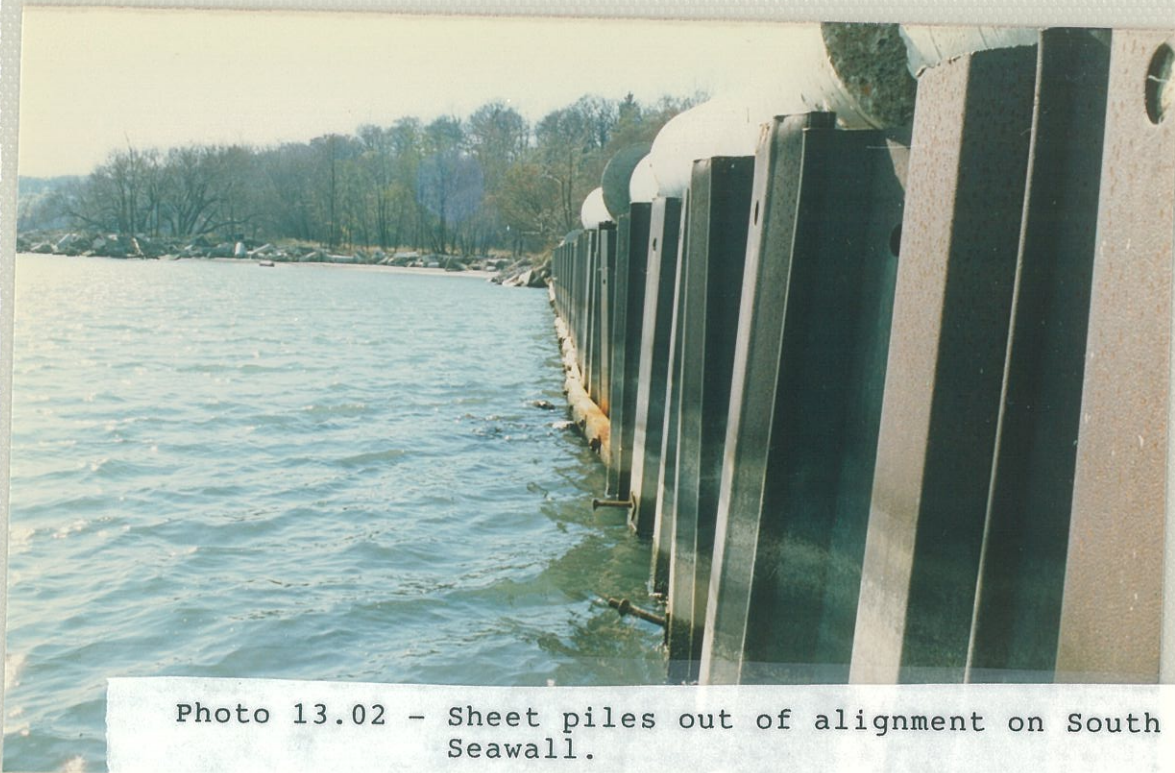
Photo 13.02 - Sheet piles out of alignment on South Seawall.

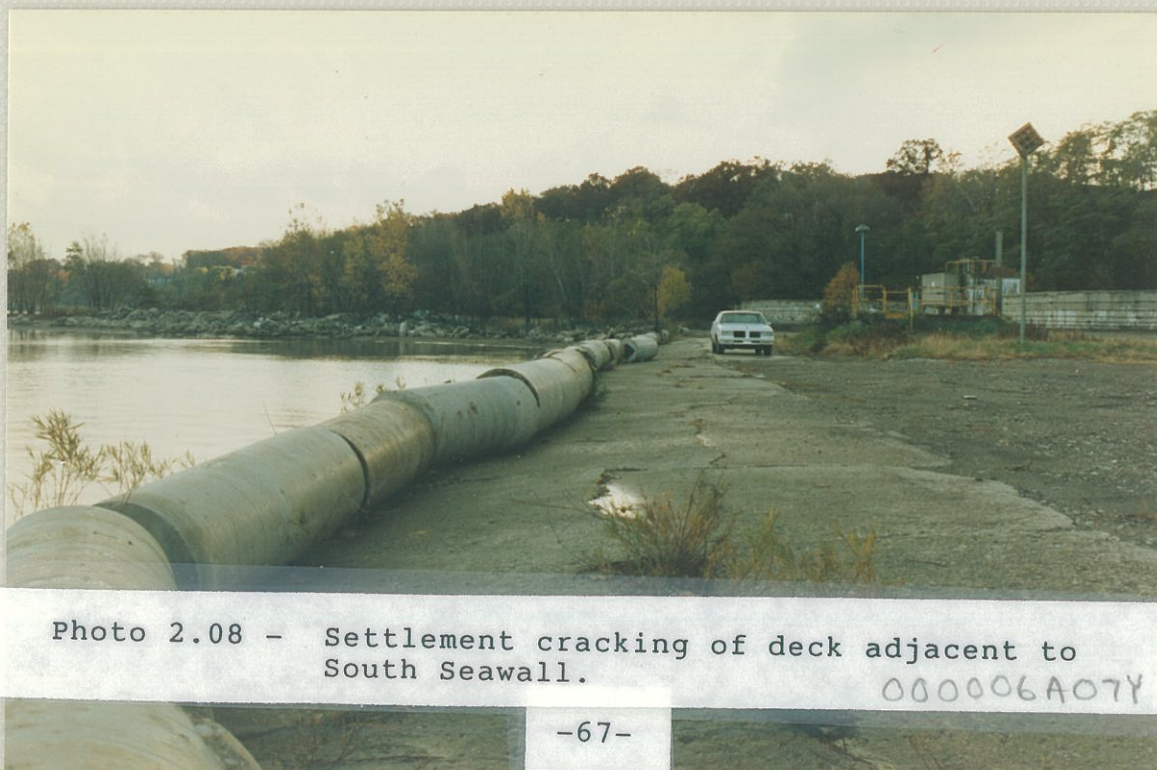
Photo 2.08 - Settlement cracking of deck adjacent to South Seawall.

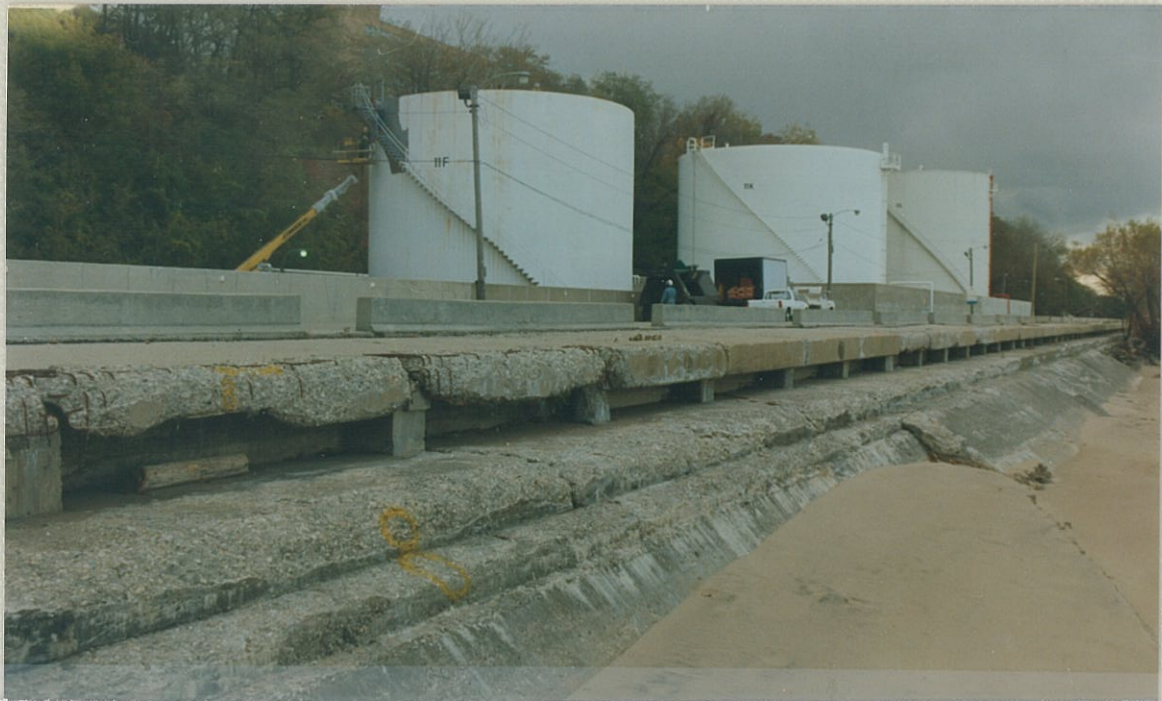
Photo 12.22 - Severe spalling of North Seawall.

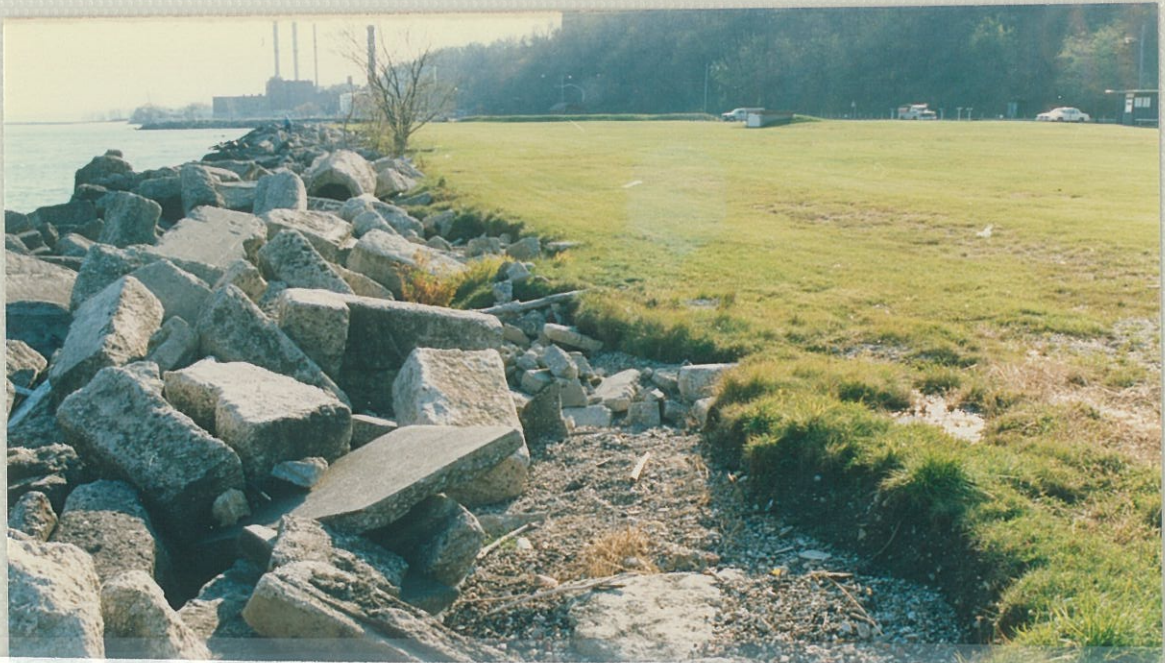
Photo 13.05 - Erosion of landfill adjacent to Riprap Groin revetment.

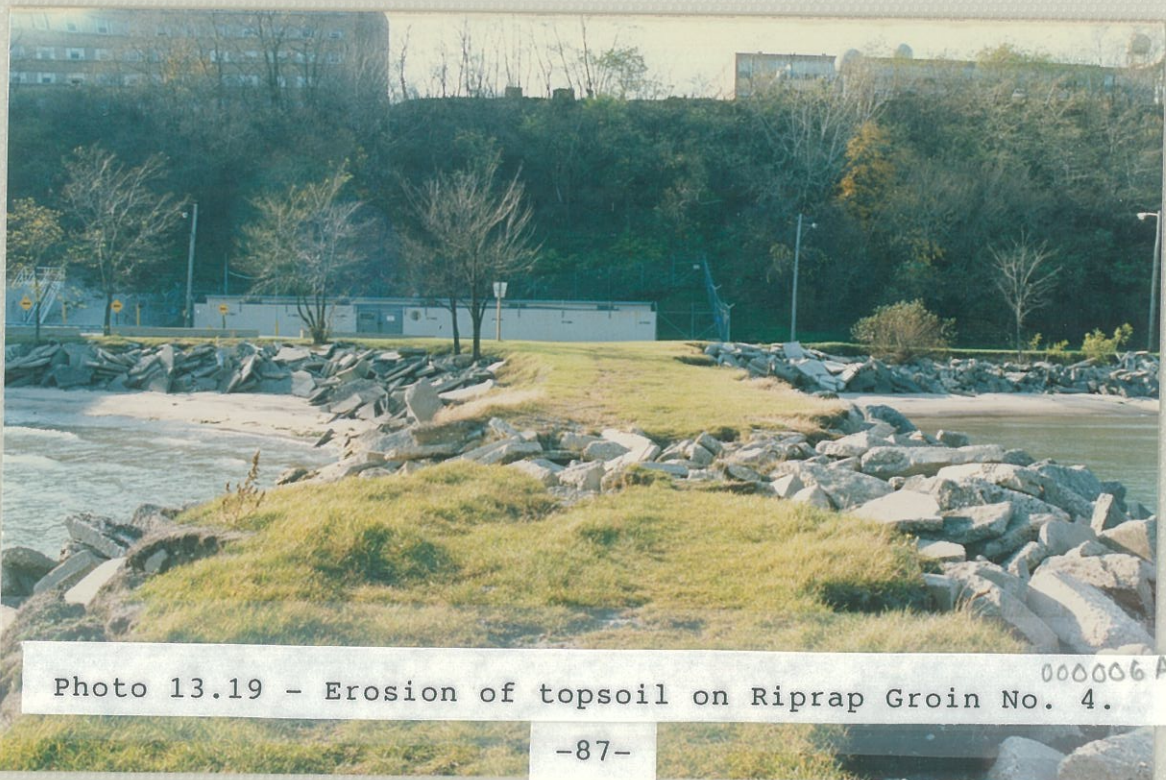
Photo 13.19 - Erosion of topsoil on Riprap Groin No. 4.
